APPL. NO.:	10/708,571
APPLICANT(S):	Peng Lee
FILED:	March 11, 2004
TITLE:	NONDESTRUCTIVE RESIDENTIAL INSPECTION METHOD AND APPARATUS
TC/A.U.:	2859
EXAMINER:	JAGAN, Mirellys
DOCKET NO.:	026018.50271

[NONDESTRUCTIVE RESIDENTIAL INSPECTION METHOD AND APPARATUS]

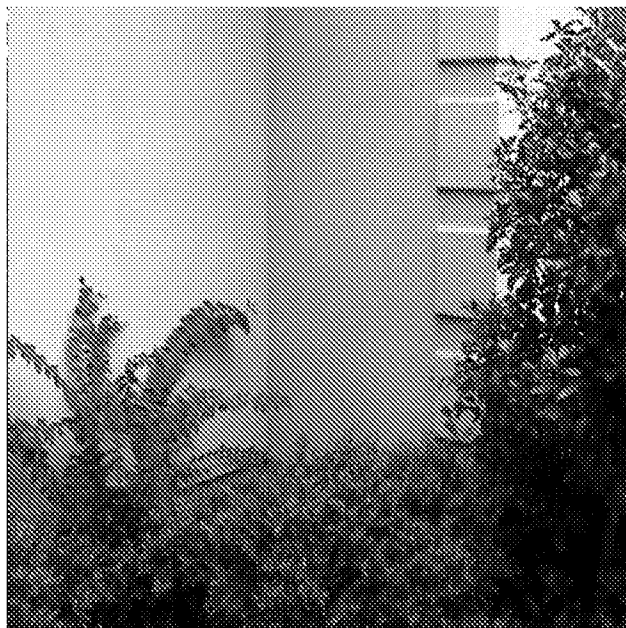
[0021] FIG. 4A is a visual photograph of an EIFS wall.

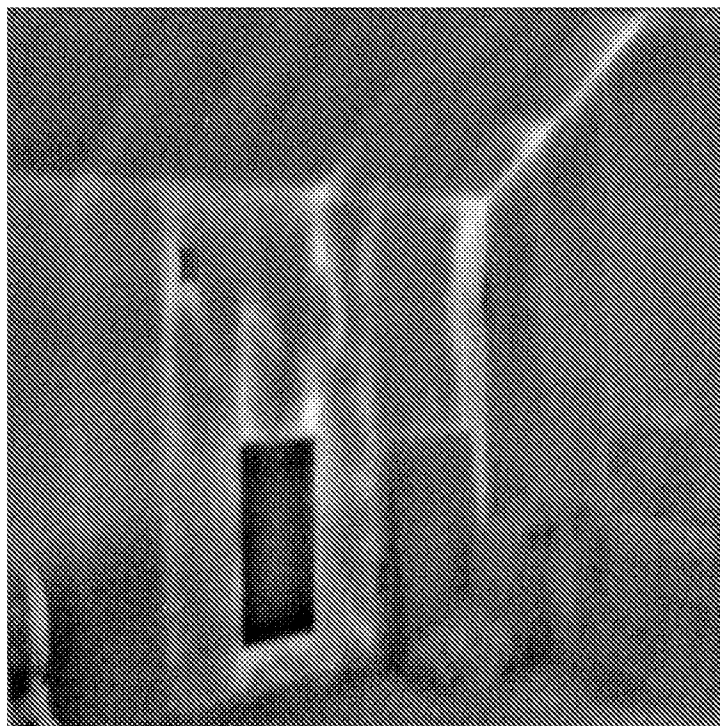
[0054] FIG. 23 is a temperature profile of a residential interior component.

[0119] (6) *Small Animals* – As for small animals, such as mice, rats, squirrels, and etc. when they infest a house attic or wall space, they tend to burrow through insulation, creating air gaps in the normally evenly distributed insulation and thereby changing the thermal properties of the insulation, leaving visual evidence of tunnels and nests that would normally be invisible to even the trained eye. FIGS. 22 and 23 are thermal profiles of an interior component of a residential building. A review of a digital recording of this thermal profile shows an anomaly that is interpreted as tunnels in insulation in the ceiling (FIG. 22) a tunnel in the insulation in the walls (FIG. 23).
